Use Attainability Analysis

WBID 0706 Auxvasse Creek

Submitted by
SES, Inc.

To
Missouri Department of Natural Resources
Water Protection Program

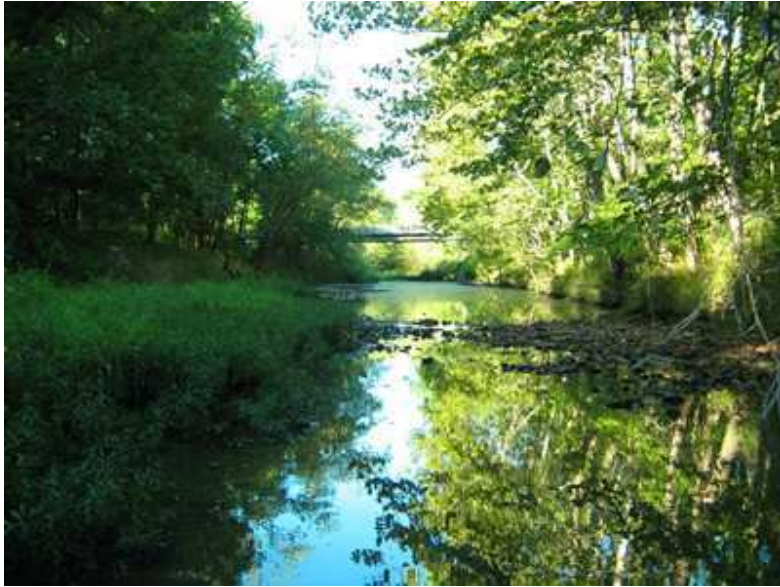
Site# 1 Photo ID# 33, Upstream

% of Channel Feature				
Riffle	27				
Run	0				
Pool	63

50% Cobble	23% Gravel	14% Sand	13% Silt
% Mud/Clay	% Bedrock

80% small willow in stream

Odor	Sewage	Musky	Chemical	<u>None</u>	Other
Color	Clear	<u>Green</u>	Gray	Milky	<u>Other</u> <u>murky</u>
Bottom Deposit	Sludge	Solids	<u>Fine Sed.</u>	None	Other
Surface Deposit	<u>Oil</u>	<u>Scum</u>	Foam	None	Other

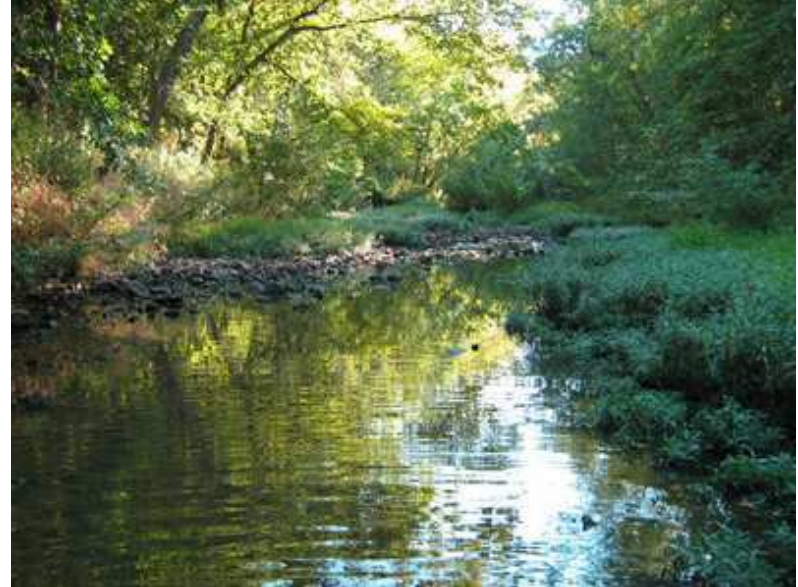
Site# 1 Photo ID# 34, Downstream

Roads	Rope swings	Foot paths/prints	Dock/platform
Livestock Watering	RV/ATV Tracks	Camping Sites	Fire pit/ring
NPDES Discharge	Fishing Tackle	<u>Other:</u>	<u>rifle found in stream</u>

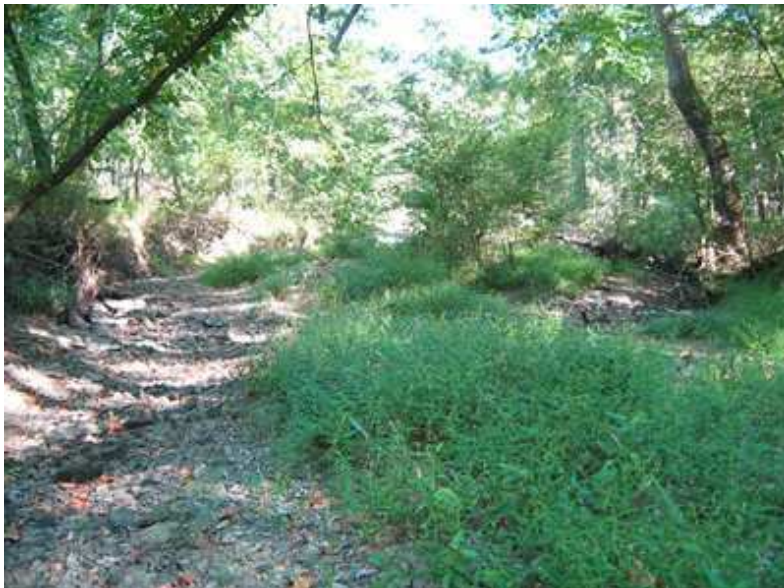
Site# 2 Photo ID# 35, Upstream

% of Channel Feature				
Riffle	91				
Run	9				
Pool	0

50% Cobble	41% Gravel	% Sand	% Silt
------------	------------	--------	--------

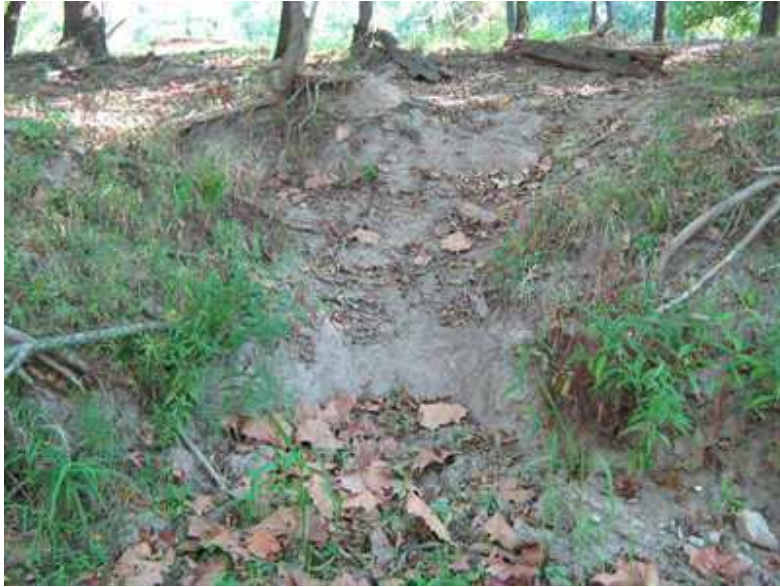
Site# 3 Photo ID# 37, Livestock watering

Roads	Rope swings	Foot paths/prints	Dock/platform
<u>Livestock Watering</u> <u>Pic #37</u>	RV/ATV Tracks	Camping Sites	Fire pit/ring
NPDES Discharge	Fishing Tackle	Other:

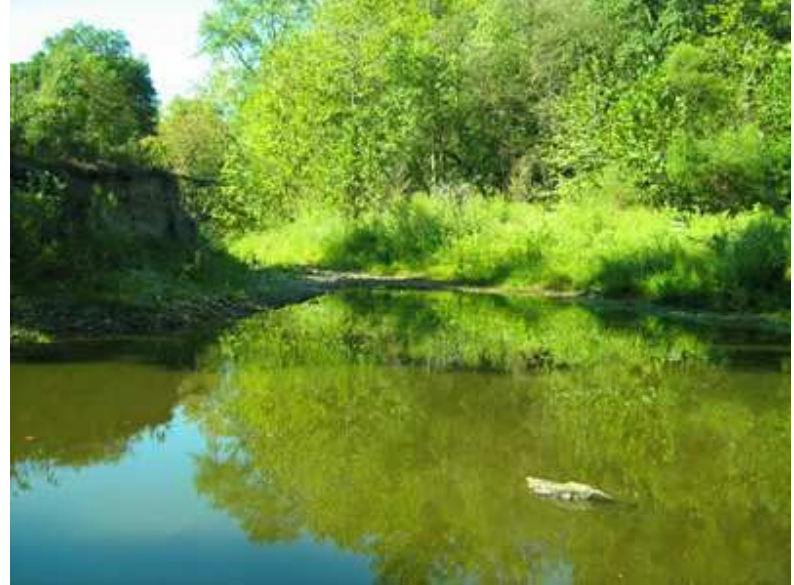
Site# 3 Photo ID# 38, Upstream

Riffle	82				
Run					
Pool	18

77% Cobble	18% Gravel	5% Sand	% Silt
------------	------------	---------	--------

Color	Clear	Green	Gray	Milky	<u>Other</u>	<u>murky, brown</u>
-------	-------	-------	------	-------	---------------------	----------------------------

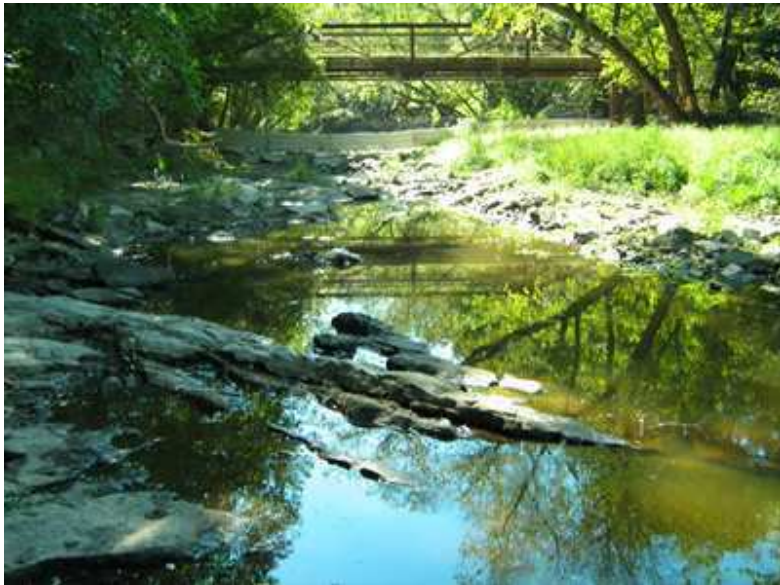
Site# 3 Photo ID# 39, Downstream

City/county parks	Playgrounds	MDC conservation lands	Urban areas
Campgrounds	Boating accesses	State parks	National Forests
Nature trails	Stairs/walkway	No trespass sign	<u>Fence: across stream</u>
<u>Steep slopes</u>	None of the Above	Other

Roads	Rope swings	Foot paths/prints	Dock/platform
Livestock Watering	RV/ATV Tracks	Camping Sites	Fire pit/ring
NPDES Discharge	Fishing Tackle	<u>Other:</u>	<u>shown in Pic#39</u>

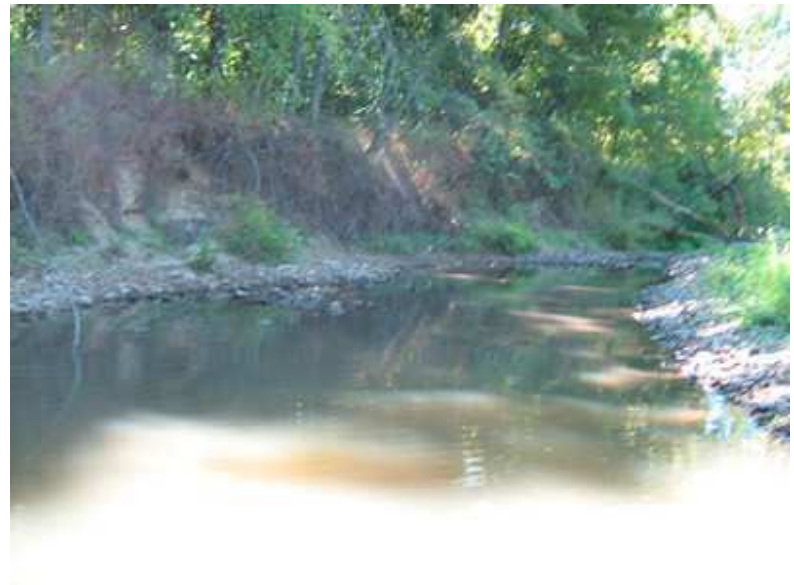
Site# 4 Photo ID# 40, Upstream

% of Channel Feature				
Riffle	27				
Run	0				
Pool	73

59% Cobble	5% Gravel	36% Sand	% Silt
% Mud/Clay	% Bedrock

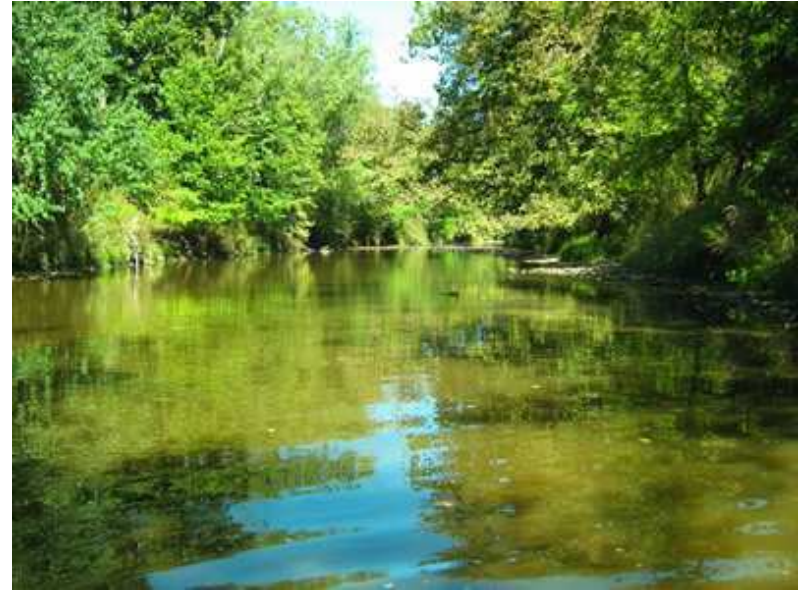
Site# 5 Photo ID# 42, Upstream

% of Channel Feature				
Riffle	0				
Run	100				
Pool	0

vegetated along banks

Odor	Sewage	Musky	Chemical	<u>None</u>	Other
Color	Clear	Green	Gray	Milky	<u>Other</u> <u>brown, murky</u>
Bottom Deposit	Sludge	Solids	<u>Fine Sed.</u>	None	Other
Surface Deposit	Oil	Scum	Foam	<u>None</u>	Other

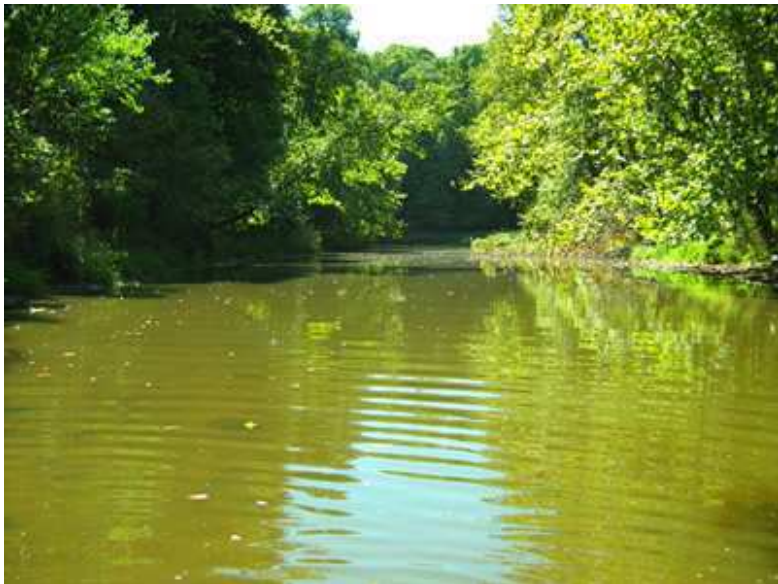
Site# 5 Photo ID# 43, Downstream

50% Cobble	% Gravel	45% Sand	% Silt
------------	----------	----------	--------

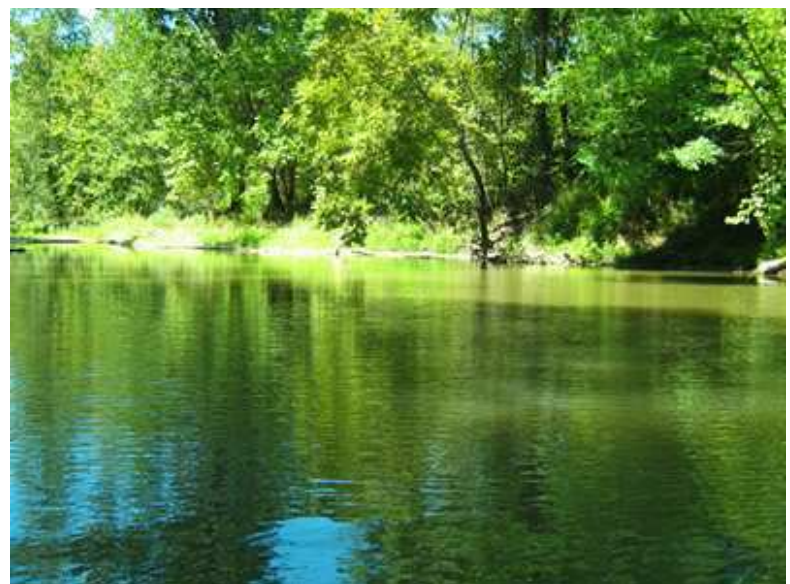
Site# 6 Photo ID# 45, Upstream

% of Channel Feature				
Riffle	0				
Run	0				
Pool	100

Odor	Sewage	Musky	Chemical	<u>None</u>	Other
Color	Clear	<u>Green</u>	Gray	Milky	<u>Other</u> <u>brown</u>
Bottom Deposit	Sludge	Solids	<u>Fine Sed.</u>	None	Other
Surface Deposit	Oil	Scum	Foam	<u>None</u>	Other

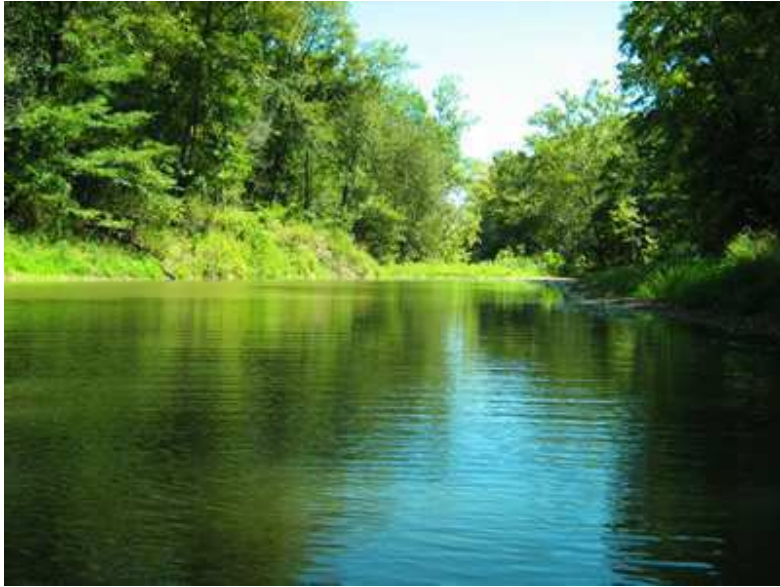
Site# 6 Photo ID# 44, Downstream

Roads	Rope swings	Foot paths/prints	Dock/platform
Livestock Watering	RV/ATV Tracks	Camping Sites	Fire pit/ring
NPDES Discharge	Fishing Tackle	<u>Other:</u>	<u>railroad tracks</u>

50% Cobble	27% Gravel	18% Sand	5% Silt
------------	------------	----------	---------

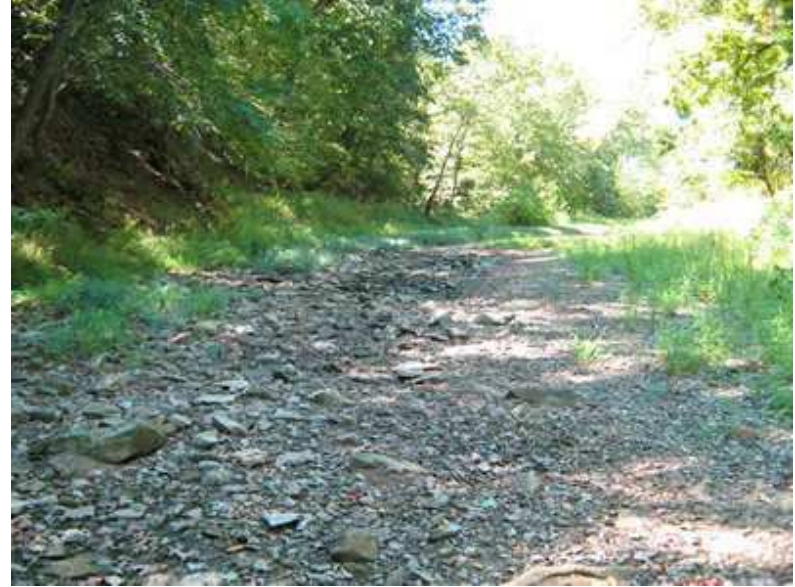
Site# 7 Photo ID# 46, Upstream

% of Channel Feature				
Riffle	95				
Run	0				
Pool	5

50% Cobble	% Gravel	50% Sand	% Silt
------------	----------	----------	--------

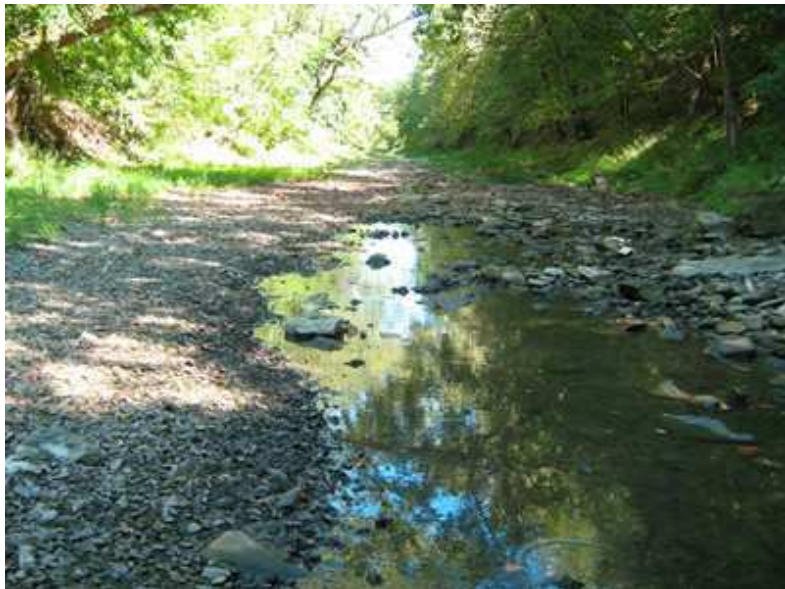
Site# 7 Photo ID# 47, Downstream

Roads	Rope swings	Foot paths/prints	Dock/platform
Livestock Watering	RV/ATV Tracks	Camping Sites	Fire pit/ring
NPDES Discharge	Fishing Tackle	<u>Other:</u>	<u>bridge</u>
